DYNAMIC SCIENCE, INC.
In-Depth Accident Investigation

Case Number DSI-96-AB-003

DYNAMIC SCIENCE, INC.
AIRBAG FIRE INVESTIGATION
CASE NUMBER: DSI-96-AB-003

Case Selection: As the result of an alleged interior electrical wiring fire, the driver's side airbag in a 1994 Dodge pick up truck self deployed. During this deployment the airbag inflator separated from the steering wheel and was projected through the rear wall of the truck cab.

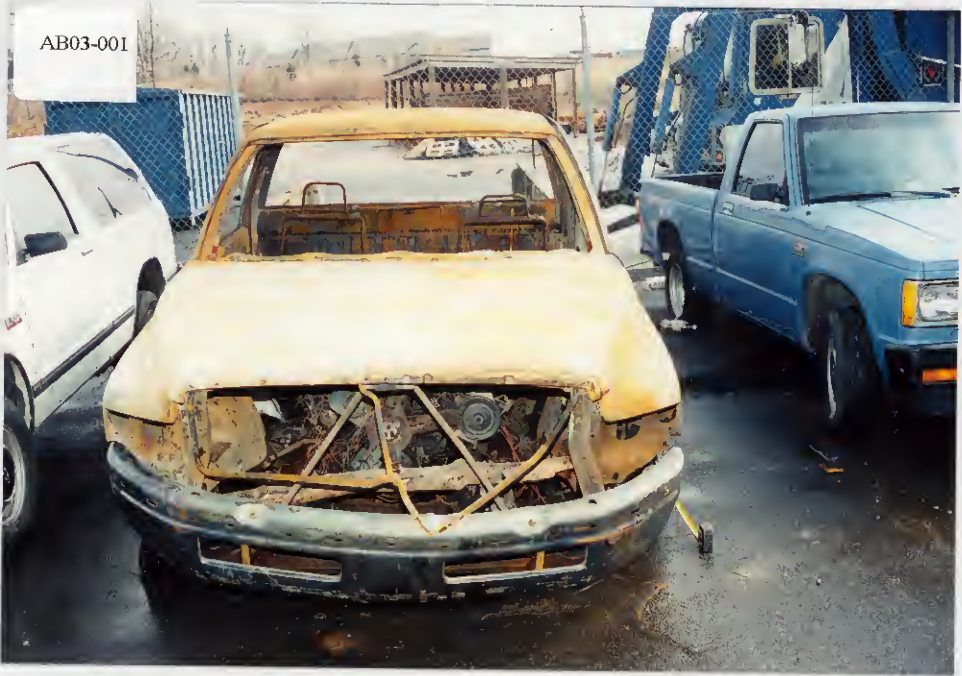
AB03-001

Front - The grille, right and left headlights, and all right and left light components were completely destroyed by direct fire contact. The left front bumper support was heat deformed and the bumper was lowered approximately 5 to 8 cm (2 to 3 in) as a result. The chrome plated bumper was discolored and the black, vinyl-like bumper insert strip was completely destroyed by direct fire contact (Photos 1 and 2). This bumper support deformation, and the lowering of the bumper, may have been the result of earlier investigations (Photo 51). The entire windshield melted and fell inward into the interior of the cab (Photos 1 and 2).

Engine Compartment - The engine coolant radiator and the air conditioning coils were completely melted by direct fire contact (Photos 1 and 2). In addition, the upper and lower radiator supports were deformed by fire and heat. All engine compartment hoses and wiring were destroyed by direct

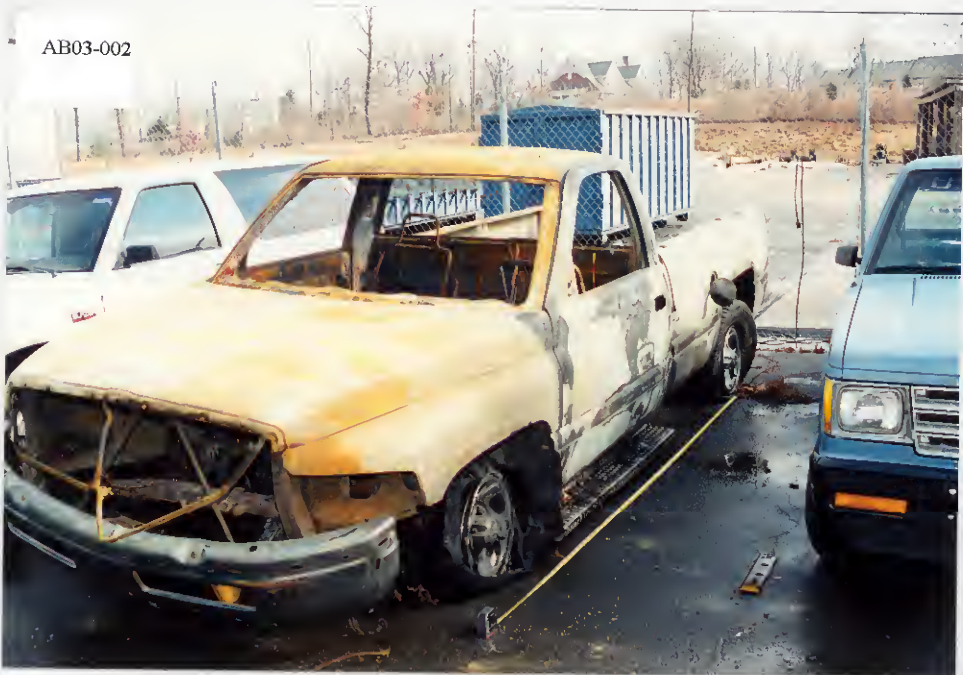
AB03-002

Left Side - The left front fender was burned to metal and was rusting (primer completely burned, temperature above 371° C (700° F). The deflated left front tire had areas of charring from direct flame contact and the chrome plated wheel was discolored by heat (Photo 2). The left front door and cargo box exterior surface showed heat damage, but the primer was gray-white in color indicating a temperature < 232° C (450° F). The black, vinyl-like left side molding was in place, showed no evidence of fire damage, but was soot covered. The gas filler door was open and charred black (Photos 2 and 5). The non-metal gas filler cap could not be located - it appears to have melted, but no residue could be found. The left aluminum running board sustained no fire damage, but several attachment screws were missing and assumed to have been destroyed by heat (Photos 2 and 5). The left door glazing appears to have melted down the exterior of the door - no left side glass residue was found inside the truck (Photos 2 and 5). The left "A" pillar was burned to the metal indicating a temperature greater than 371° C (700° F) (Photos 1 and 2). The deflated left rear tire was charred and the chrome plated wheel was discolored by heat (Photos 2 and 5). There was no apparent heat deformation of the left side plane metal. Black areas on the left side appeared to be charred paint (Photos 5 and 7).

Cab Top - The entire top of the cab was devoid of primer and was rusting. In addition, the top was depressed on the center left side as a result of heat induced temper loss (Fire Department temperature estimate $>483^{\circ}\text{C}$ (900°F)) (Photos 2 and 11).

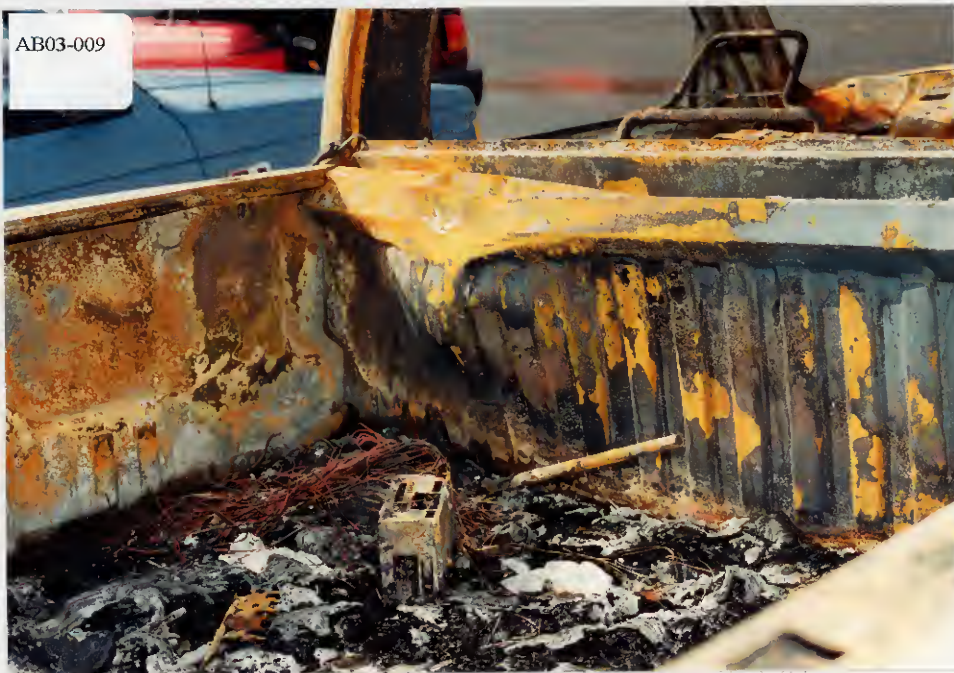
AB03-009

Cargo Box - Residue from the burned fiberglass cap covered the bed of the cargo box (Photos 9, 54 and 55). The right side interior wall sustained heat damage, but the gray-white primer remained indicating a temperature in the area of $<232^{\circ}\text{C}$ (450°F) (Photos 5 and 7). The left side and front walls sustained fire damage and were rusting indicating a temperature $>371^{\circ}\text{C}$ (700°F) in these areas (Photos 6 and 8).

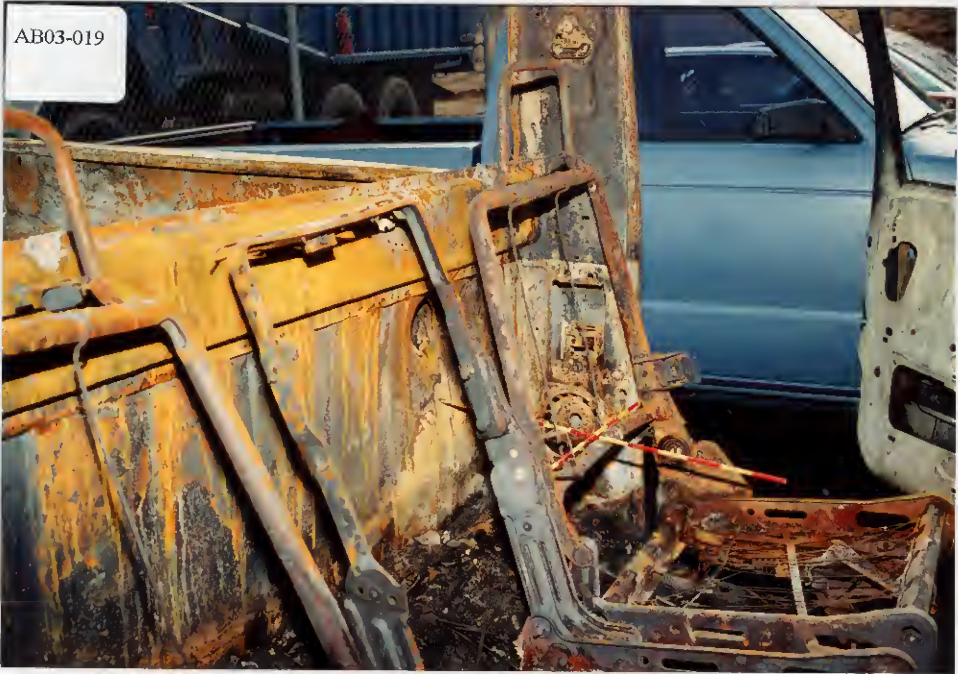
AB03-019

Interior - The vehicle interior was completely gutted with all fabric, vinyl and plastic trim being completely burned to unidentifiable residue left on the floor of the vehicle. The interior burn patterns were relatively uniform with the right side and entire instrument panel sustaining the severest damage (Photos 21 and 22). In these areas, the temperatures are estimated to have been well above 371° C (700° F) with metal deformation and the melting of attachment screws on the left instrument panel and steering column. The back wall of the cab, and the left front seat sustained estimated temperatures ranging from 232° C (450° F) to >371° C (700° F) (Photos 14-20). The interior trim panel of the left front door was completely burned, but the metal door surface retained the gray/white primer indicating the door was subject to temperatures estimated to have been <232° C (450° F). The condition of this door indicates that it was, in fact, open during the course of this fire (Photos 19 and 20).

The left rear wall of the truck cab contained an 8.5 cm (3.3) diameter hole. This hole was located, on center, 32.5 cm (12.8 in) right of the left door latch pillar, 35.6 cm (14 in) above the rear floor and 36.8 cm (14.5 in) below the lower edge of the rear window. This hole, made by the airbag inflator, completely pierced the rear wall and was in direct line with the cargo box deformation (Photos 13-20).

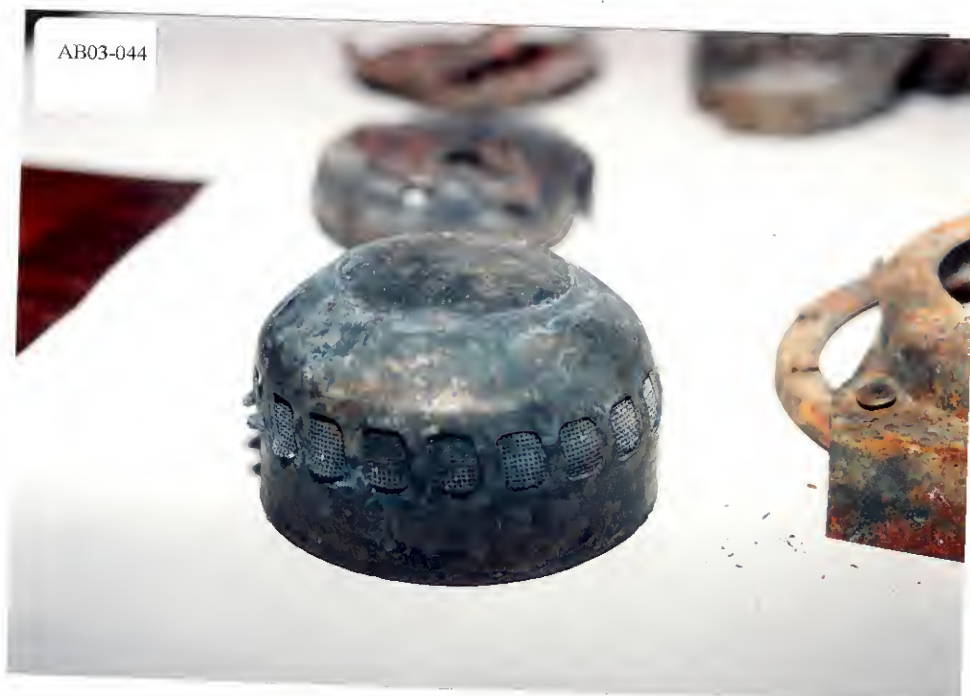
AB03-044

1. The diffuser and combustion chamber were found between the back wall of the truck cab and the front wall of the cargo box. Remnants of the final filter were attached to the diffuser (Photos 44, 45, 49 and 50).
2. The top of the diffuser was convex from internal pressure (Photos 44-46).

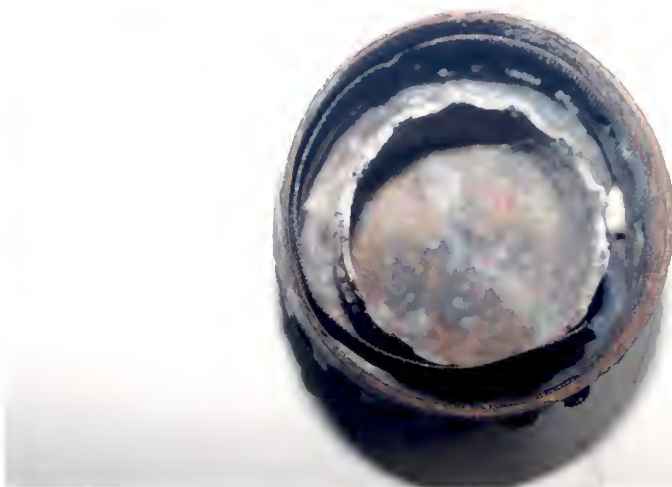
AB03-047

7. The steering wheel's airbag module attachment point was deformed (Photos 26-31).
8. It appears that the diffuser and combustion chamber were forcibly separated from the chamber cover (Photos 34-37 and 47-50).
